Service Bulletin 69

Subject: Seat Belt Anchor Points

Applicability: All GlaStar and Sportsman Aircraft

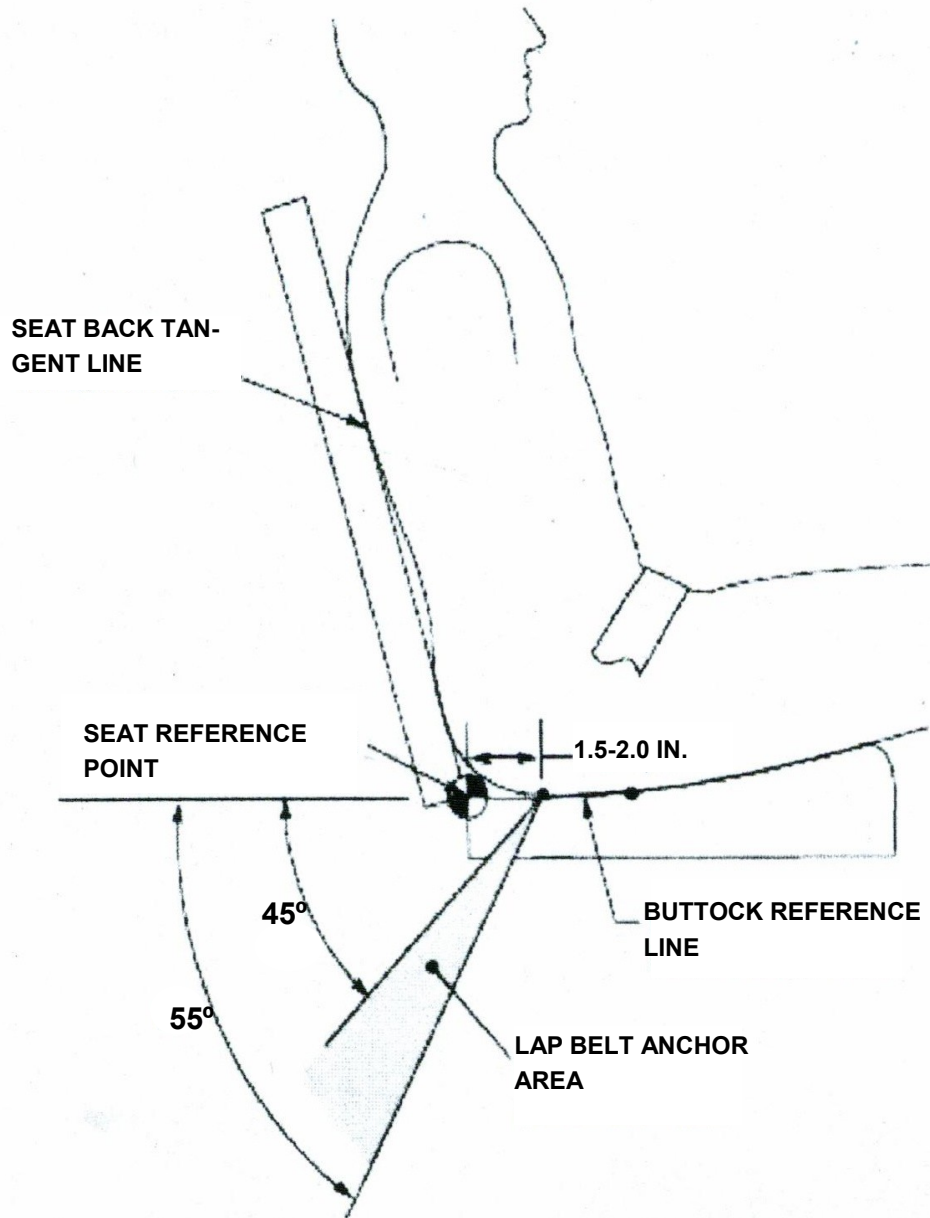
FAA Advisory Circular AC21-34 Shoulder Harness - Seat Belt Installations provides information and guidance for installation of shoulder harness and safety belt restraint systems. AC21-34 recommends that lap belt anchor points mount so as to maintain an angular range of 45° - 55° for all seat range positions. (See Figure 1 on the next page)

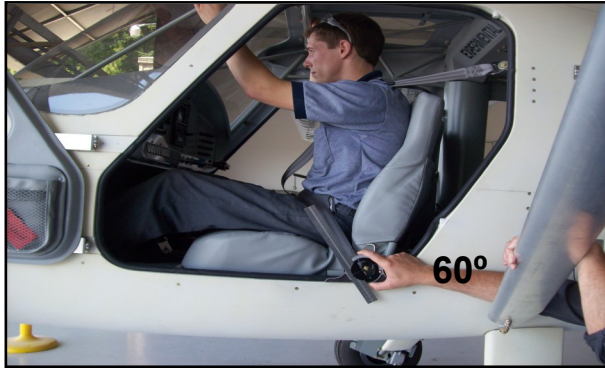
As currently configured, the GlaStar / Sportsman lap belt anchors can fall outside of the recommended angular range, especially when the seat backs are in the mid to aft locations. (See photos in appendix.)

Current configuration:
Seat-back in forward position

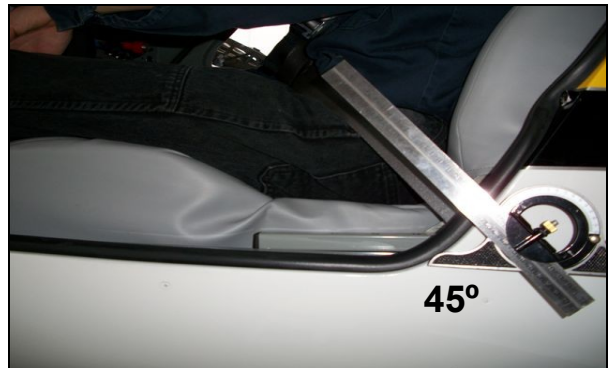
Retrofit (New) configuration:
Seat-back in forward position

To bring GlaStar / Sportsman lap belt anchor points to within the suggested angular range, Glasair Aviation recently relocated the lap belt anchor points on production cage assemblies.

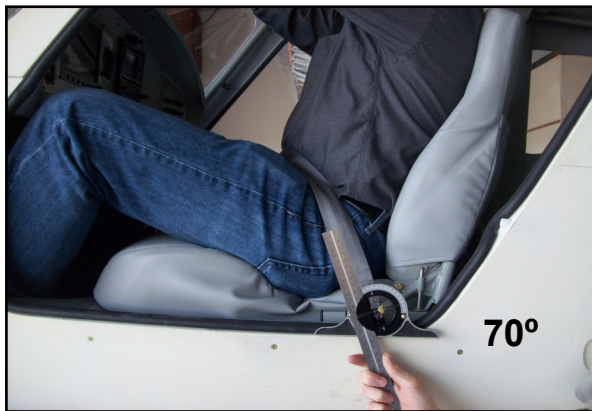
Current configuration:
Seat-back in mid-position

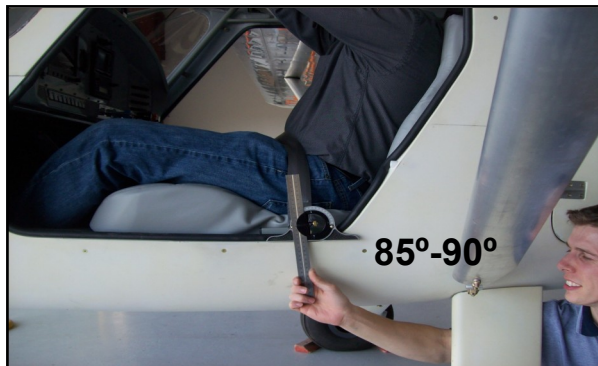
Current configuration:
Seat-back in aft position

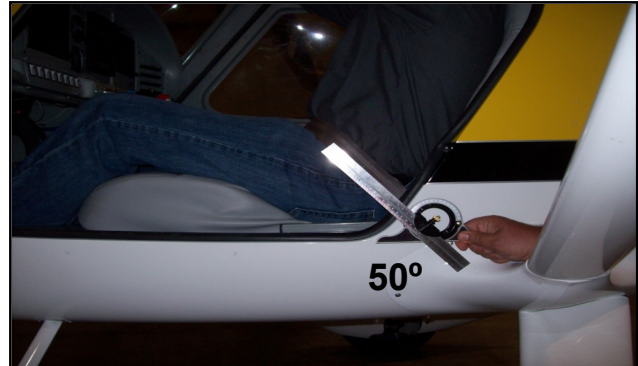
Retrofit (new) configuration:
Seat-back in aft position
